ERDC/CERL TR-00-24

## **Condition Assessment of Building 6237, Old Hospital Complex, Fort Carson, CO**

by Thomas R. Napier and Sheila A. McCarthy

August 2000

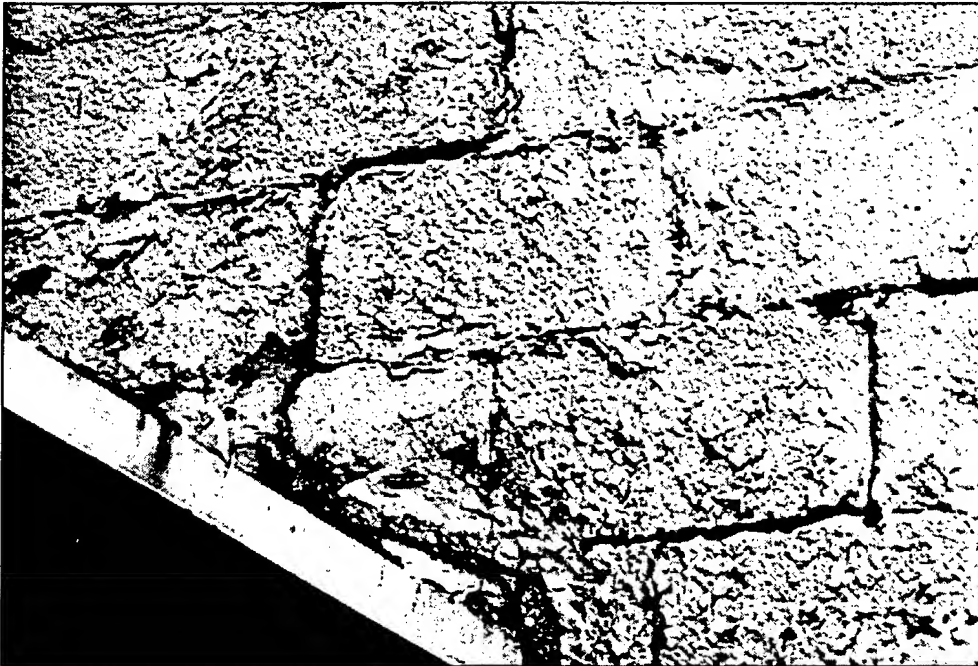
There were two locations in the west exterior wall where cracking was serious: one at the south center entry door (Point A and Figure 3-5), and one adjacent to the ninth\* window from the north (Point B and Figure 3-6). However, no cracking or settling was observed in the exterior foundation wall at these locations.

Figure 3-5. Detail of cracking.

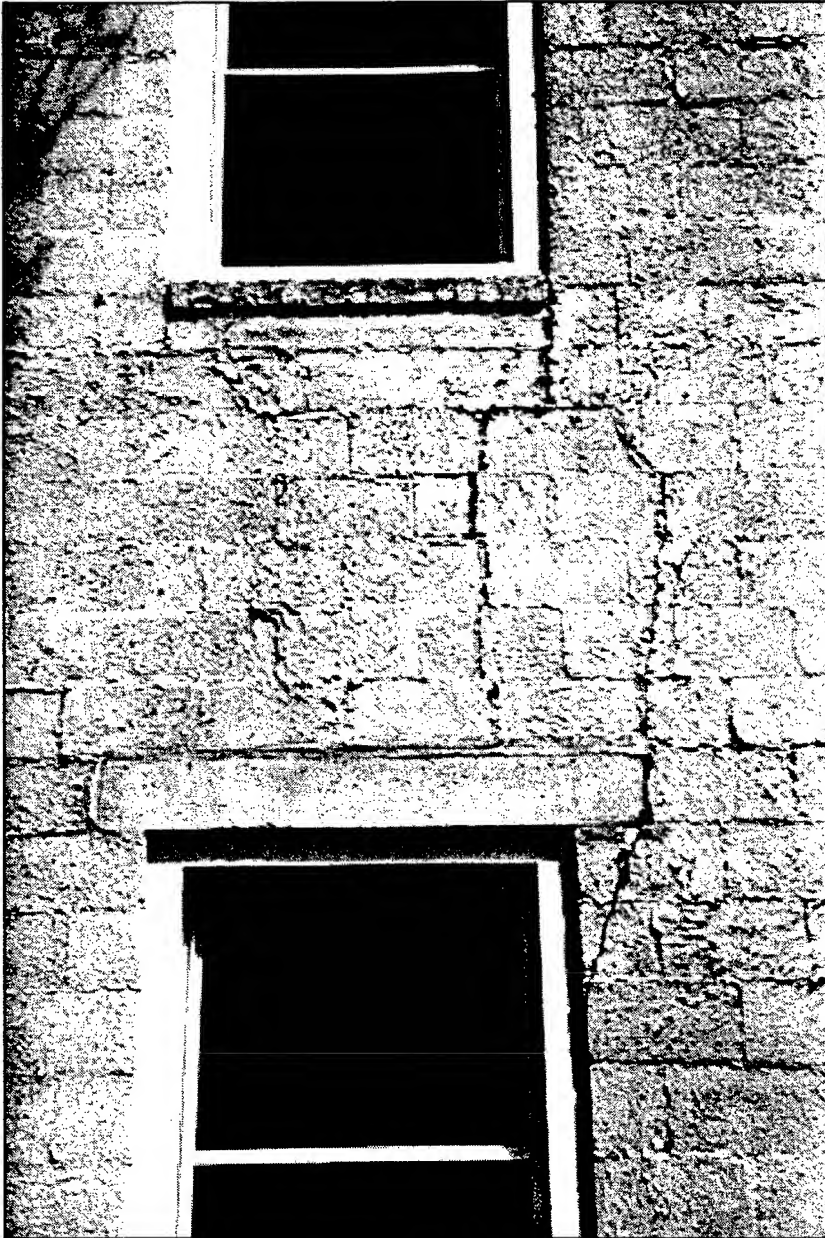
Figure 3-6. Detail of cracking adjacent to ninth window from north.

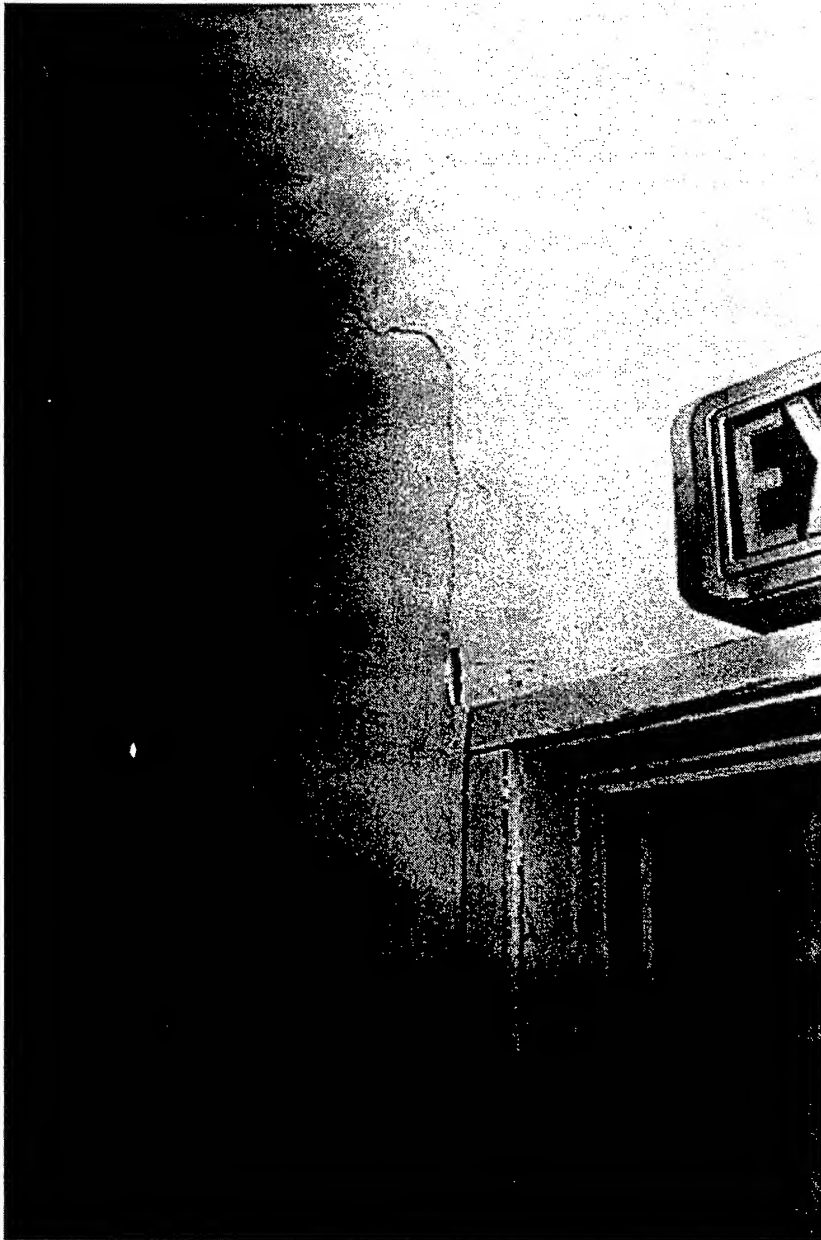
Figure 3-11. Cracking in wall of center stairs.

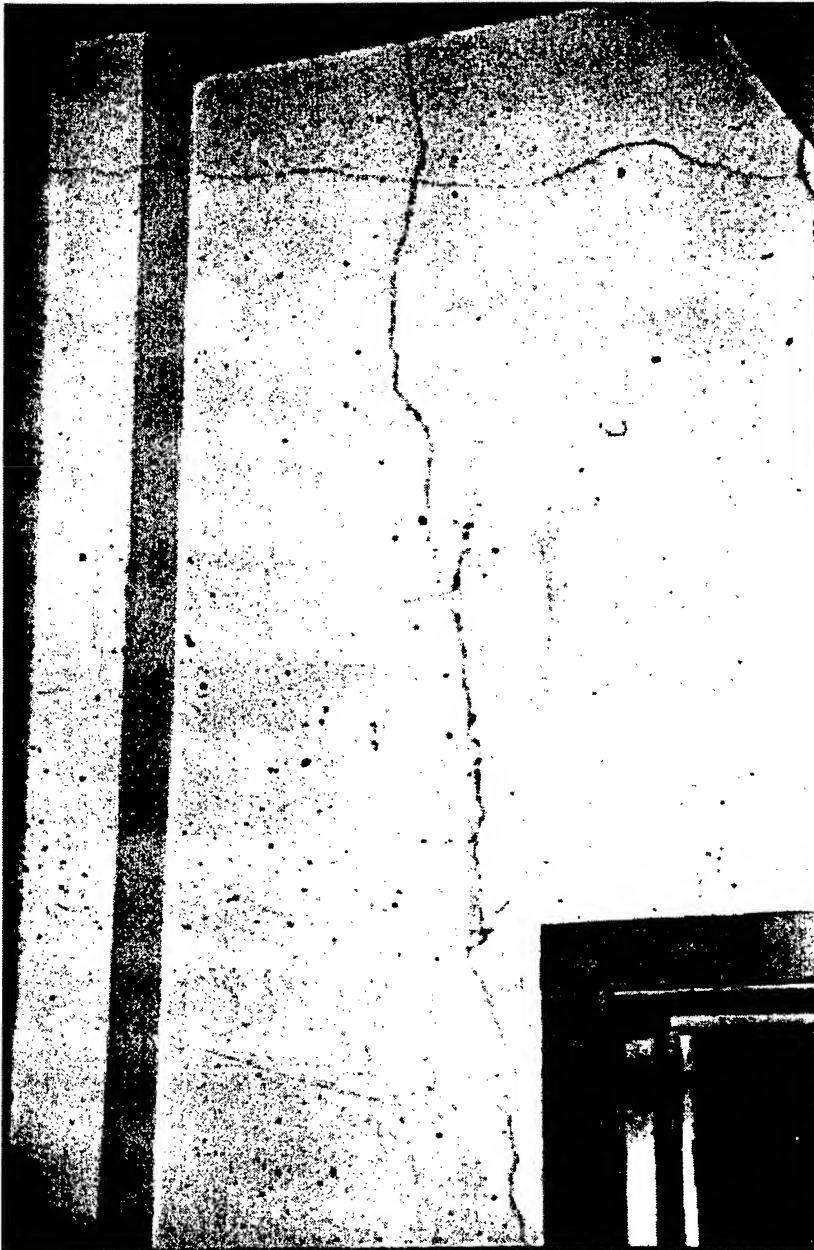
Figure 3-12. Vertical crack in firewall, first floor north ward.

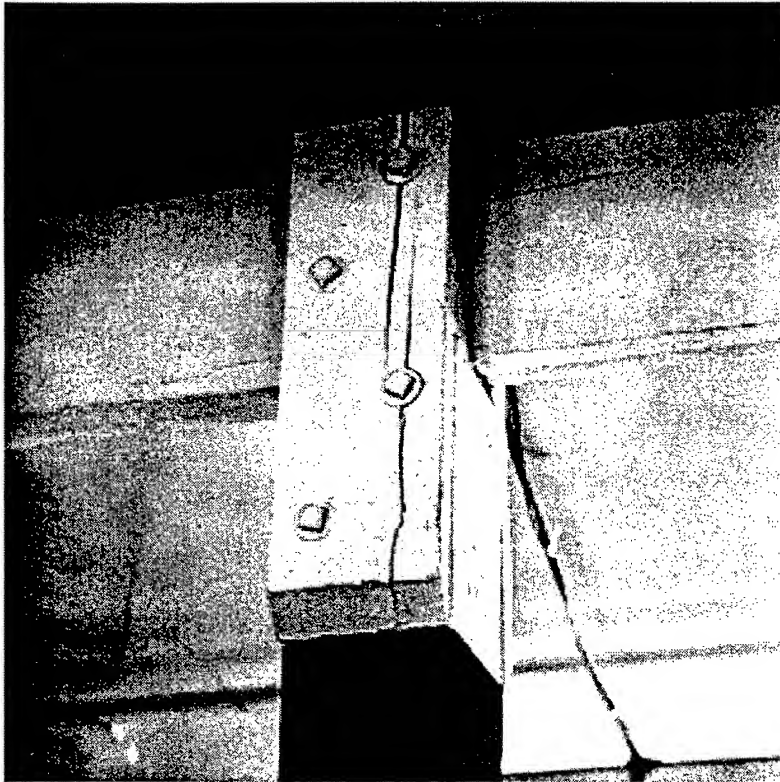
Vertical splitting had occurred at the “beam pockets” at the tops of the columns at the bolts (Figure 3-17). These pieces do not carry vertical loads, and no lateral dislocation of the beams was observed. Paint was evident within these splits, suggesting that they had been stable for quite some time.

Figure 3-17. Splitting at beam pocket.

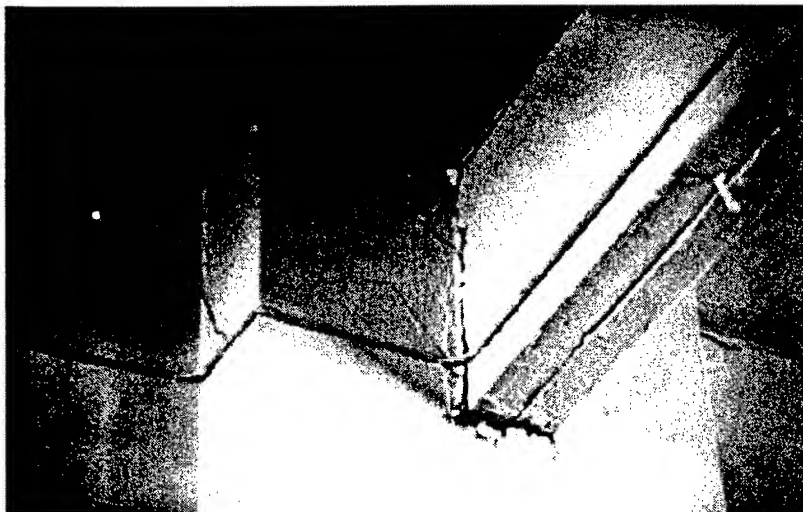
The north end of the beam on the west side of the south open ward is carried by a pilaster in the firewall (Point N). Cracking in the plaster below this beam was observed (Figure 3-19). There was a space of approximately  $\frac{1}{2}$  in. under the beam, suggesting that the beam may not be bearing flush on the pilaster. Apparently this allowed the beam to settle slightly and crush the plaster finish. However, there was no other evidence of structural movement (Figure 3-20).

Figure 3-19. Cracking at beam/pilaster connection.

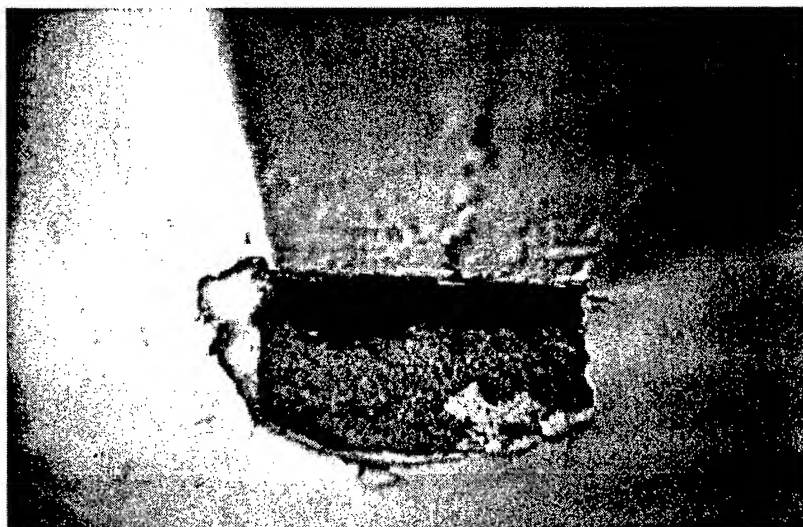
Figure 3-20. Gap below beam.

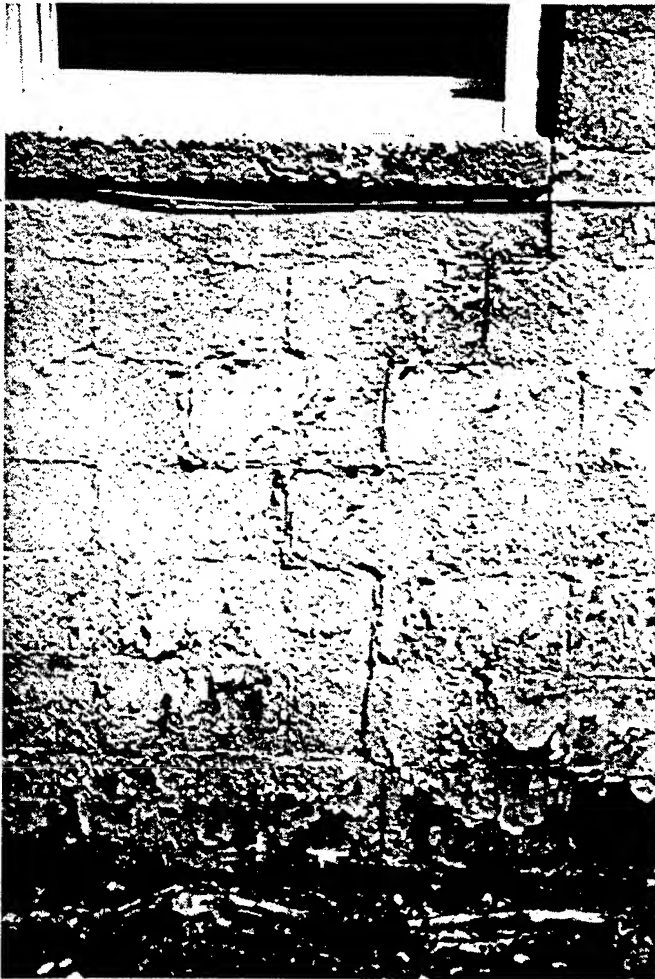
Cracking was observed throughout the exterior cinder block walls. Cracks typically radiated from the corners of window openings, and followed the stair-step pattern of the mortar joints (Figure 3-21). Occasionally cracks would split blocks vertically. Cracks were generally minor, 1/8 in. or less, although larger gaps occurred where mortar was deteriorated or absent (Figure 3-22). Exterior walls showed no evidence of vertical displacement. Framed assemblies carried by exterior walls were found to be level. Windows could be opened and closed without binding. No signs of bowing in either a vertical or horizontal direction were observed at any exterior wall; they were straight and plumb.

Figure 3-21. Stair-step cracking.

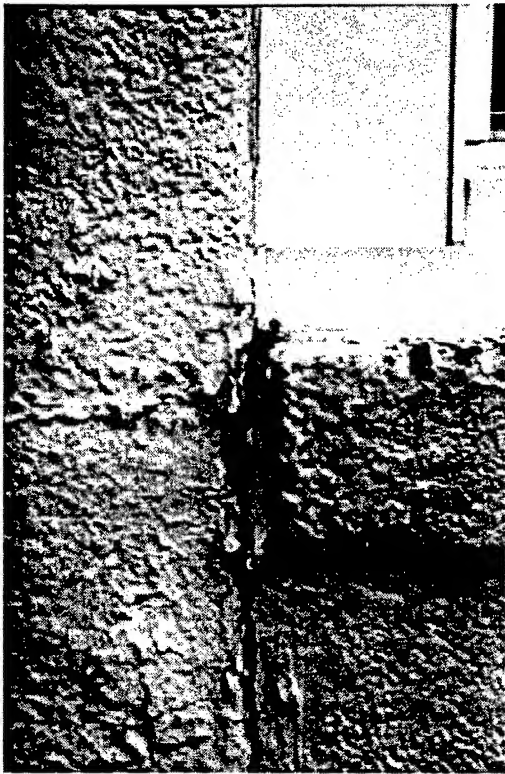
Figure 3-22. Mortar gaps at window sills.

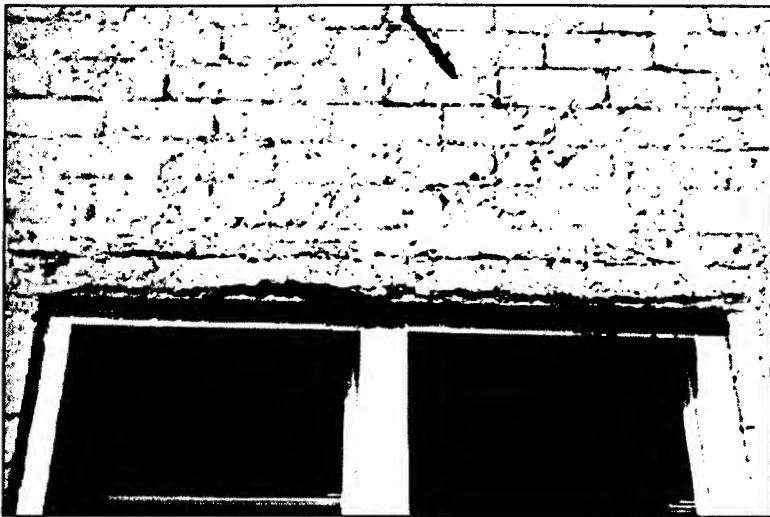
Serious distress was observed at some lintels. Lintels on the end walls (north and south walls) apparently had been parged several times, and were bulging noticeably (Point Q and Figure 3-23). On the west wall, first floor lintels had been replaced with concrete lintels, presumably reinforced (Figure 3-24). The second floor lintels appeared to be intact and exhibited no cracking. On the east wall, all the cinder block lintels remained, and most first floor lintels were seriously cracked (Figure 3-25). The most severely cracked was in the east wall, at the southernmost window of the former open ward (Point R and Figure 3-26). Deformation of almost an inch was seen in the interior trim at that window's head. Severe cracking has occurred in the interior wall and ceiling immediately adjacent to that window. Ceiling cracking was also observed adjacent to the center window in the south endwall. The lintel over that opening had apparently been cracked, and had been parged over. Water penetration through this lintel may have contributed to the ceiling cracking.

Figure 3-23. Parged and bulging lintel.

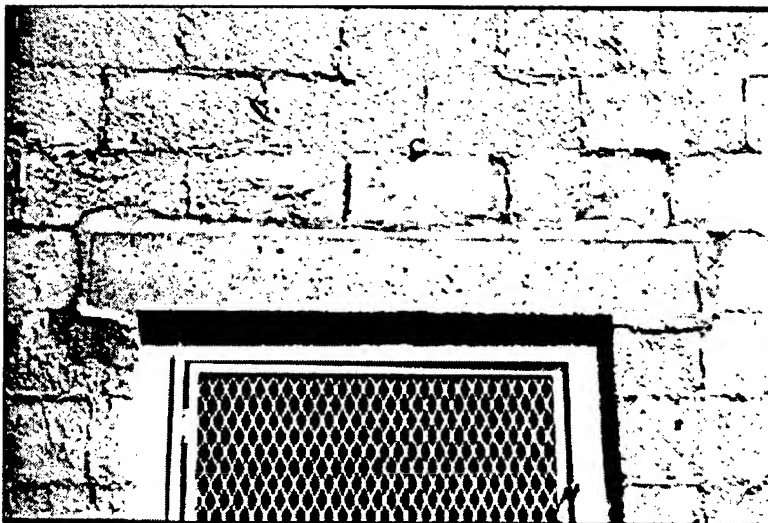
Figure 3-24. Concrete lintel replacement.

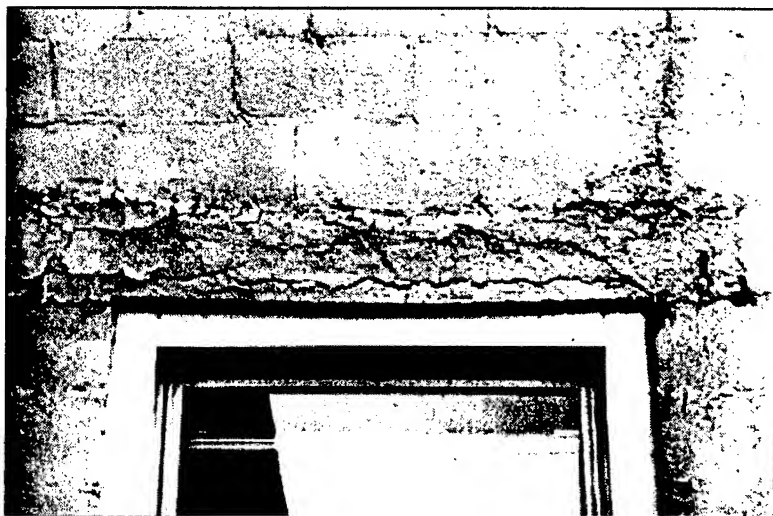
Figure 3-25. First floor lintel.

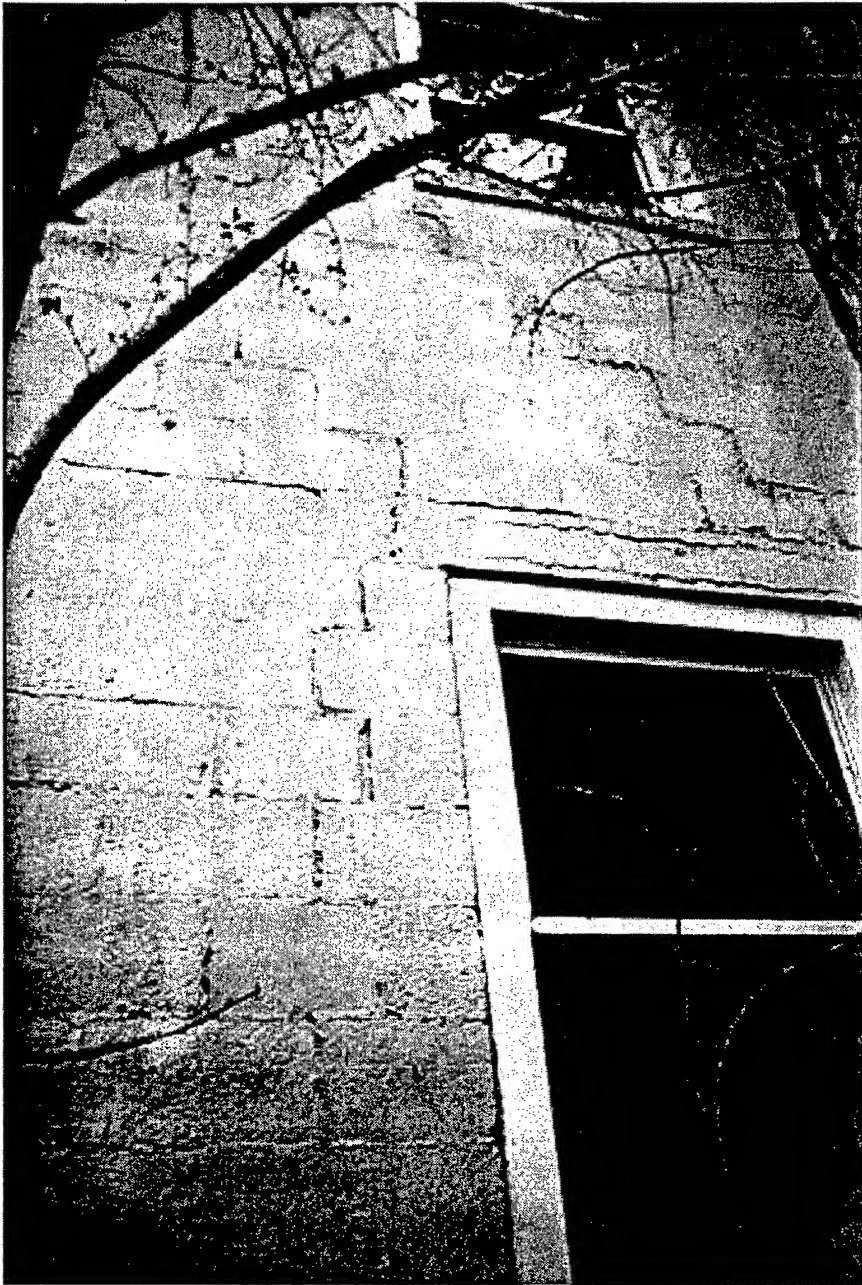
Figure 3-26. Most severe cracking at southeast window.

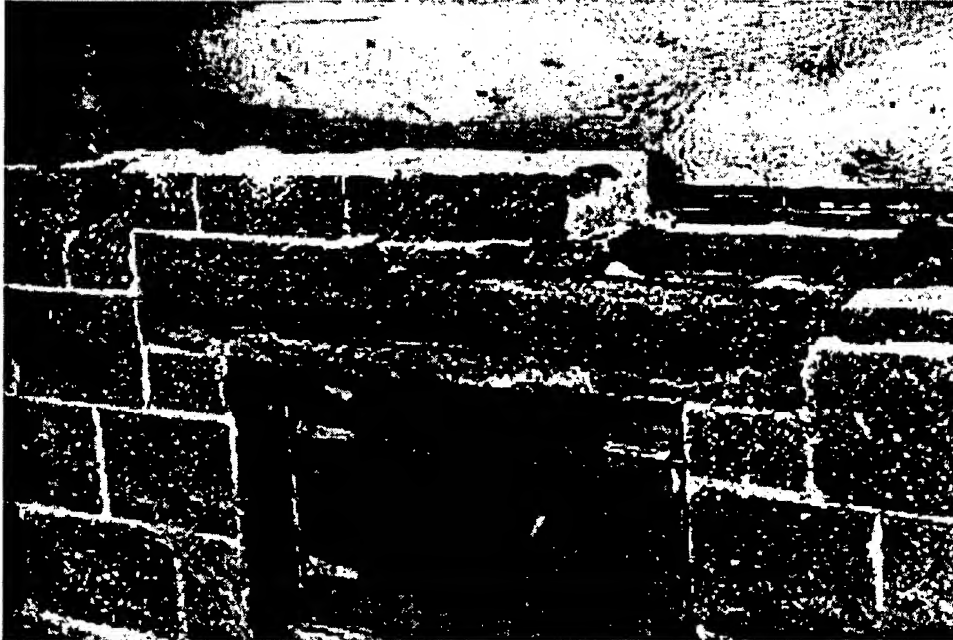
Cracked lintels were observed in Buildings 6240 and 6241, where the exterior paint and interior finishes were removed. It was clear that the reinforcing had become rusted, flaked, and spalled the cinder block cover, exposing the reinforcing (Figure 3-27). It is not apparent whether the cracks were originally caused by loading forces, or whether water penetration caused corrosion of the reinforcing, and weakened the lintels.

Figure 3-27. Exposed reinforcing in lintel (adjacent building).

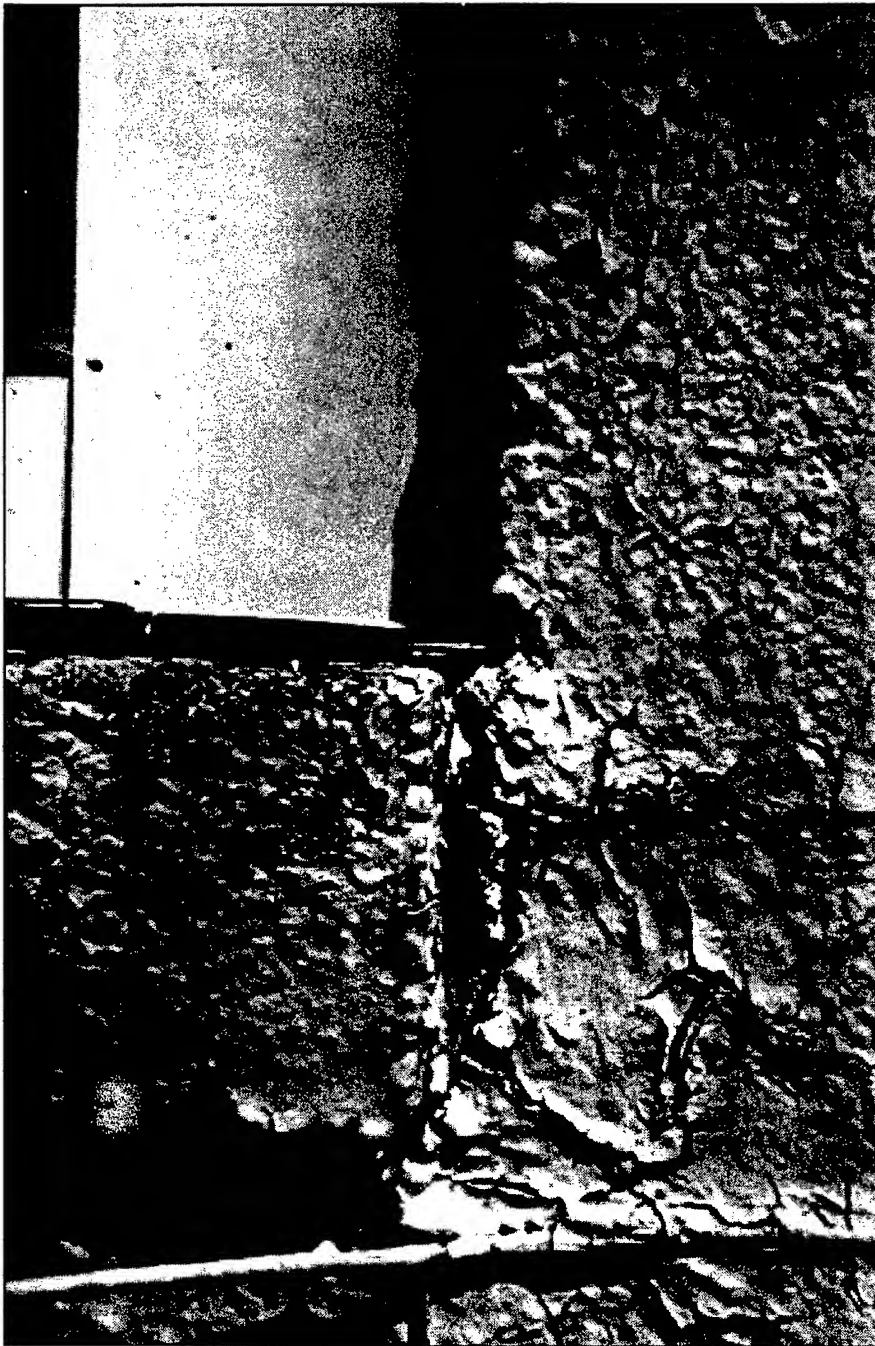
Figure 3-28. Shrunken mortar.

Regardless of the cause, it is evident that extensive repointing and painting is necessary to restore weather resistance integrity. Whether the entire wall surface must be repointed, or whether there may be areas where mortar is intact can be evaluated when the old paint is removed. There is approximately 18,000 SF of exterior masonry surface. If the structure is stable, recurrence of cracking is not imminent. Consideration must be given to mortar, sealant, and paint materials and their compatibility with the type of block used for these buildings. Consideration must also be given to providing some measure of stress relief in the exterior walls to accommodate thermal movement and minor structural movements.

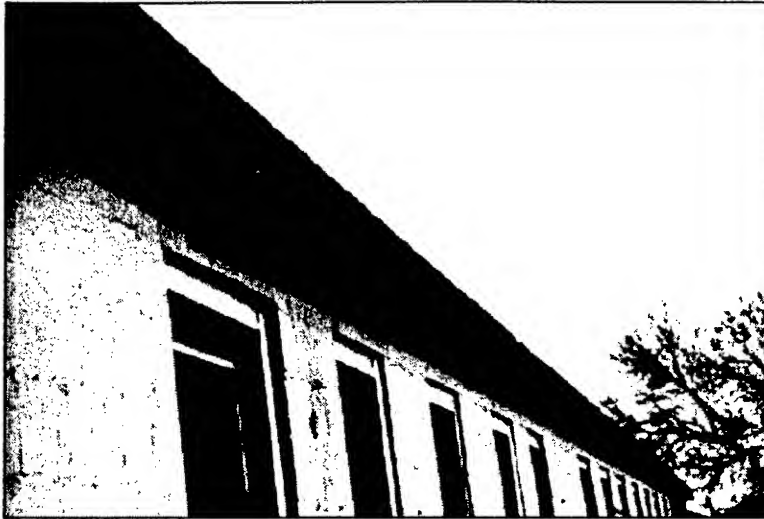
The eave trim appears to be generally intact throughout the main portion of the building. The paint is generally intact. Warping and shrinkage are evident. Warping generally has only opened up gaps in the eave trim (evidenced by daylight visible from the attic spaces), although one fascia board on the west side is severely warped (Point T and Figure 3-30). It is apparent this is caused by the lumber drying out, as opposed to structural movement.

Figure 3-30. Warped fascia board.

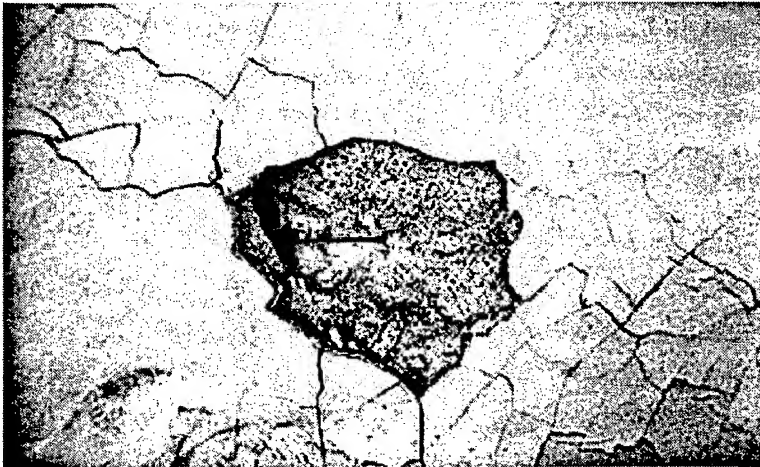
The plaster wall finish in the core areas, both within the rooms and in the hallways, appears to be in overall sound condition. However, there are numerous cracks and defects, most of which appear to be cosmetic. Damage from attached items and penetrations has also occurred throughout these areas. Damage appears behind radiators, where constant heating has spalled the finish coat away from the sheet lath (Figure 3-32). This damage occurs at almost every radiator, and there is at least one radiator in each room. In some places, plywood or Masonite boards have been nailed to the wall behind the radiator.

Figure 3-32. Spalled plaster behind radiators.
